HP Indigo Division Technical Note

Subject: Toray MET-BOPP PRF feasibility test report

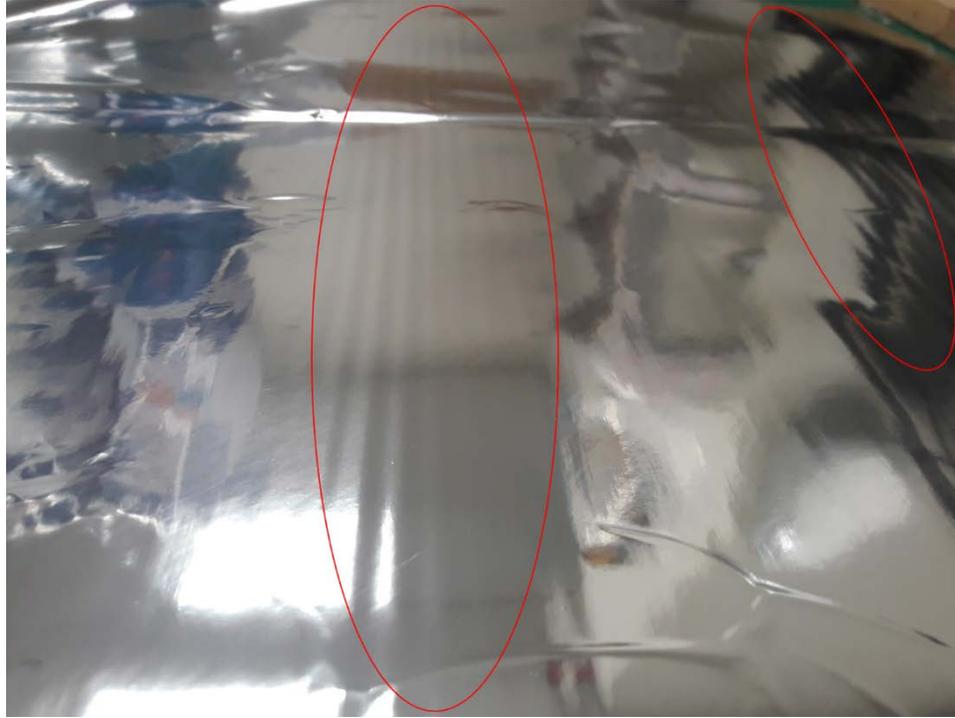
Figure 1. MET-BOPP (XR589) visual inspection showing wrinkles in film

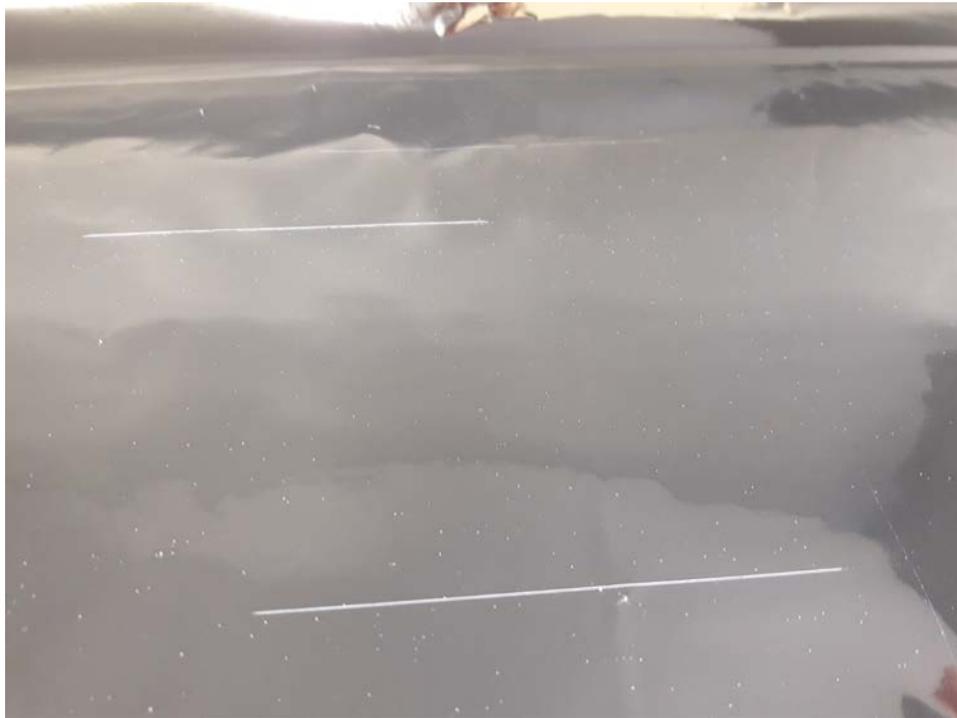
- The Thickness of the film should be 30um (based on the spec of the TAP being 10um), the measured thickness suggests a TAP thickness below the desired spec.
- Holes and cracks in the metallized layer may reflect damage to barrier layer in terms of OTR/WVTR.
- The tackiness of film XR588 makes it extremely hard to handle and not usable.

Figure 3. MET-BOPP (XR589) visual inspection of metallized layer (using back-light) showing holes and scratches in metallized layer

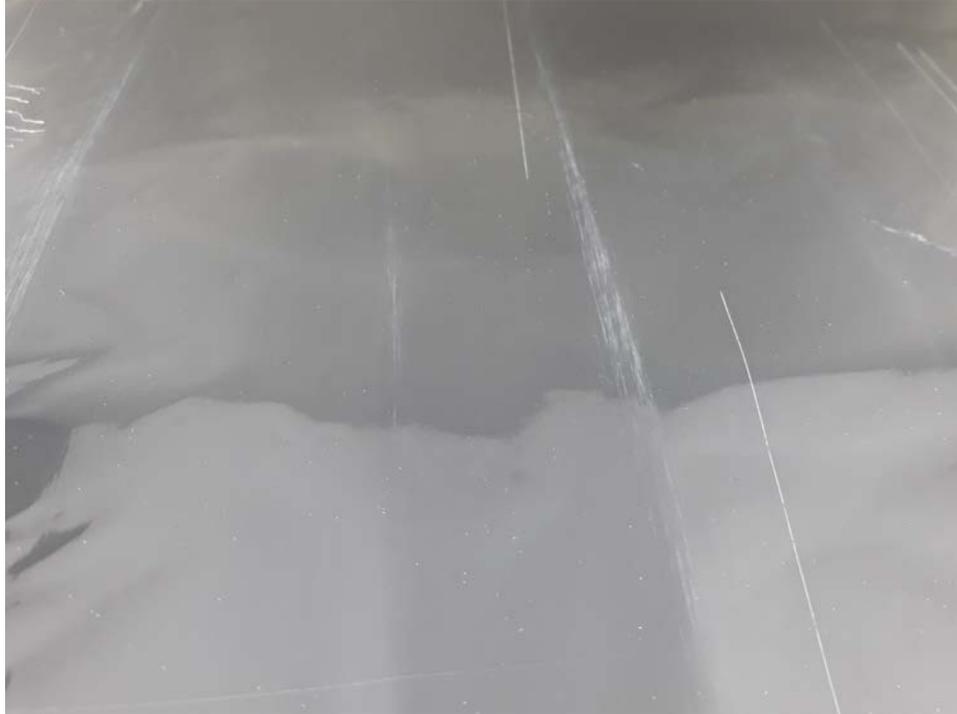
Figure 4. MET-BOPP (XR588) visual inspection of metallized layer (using back-light) showing holes and scratches in metallized layer
